ADVISORY CIRCULAR 43-16A

AVIATION MAINTENANCE ALERTS

ALERT
NUMBER
290

SEPTEMBER
2002

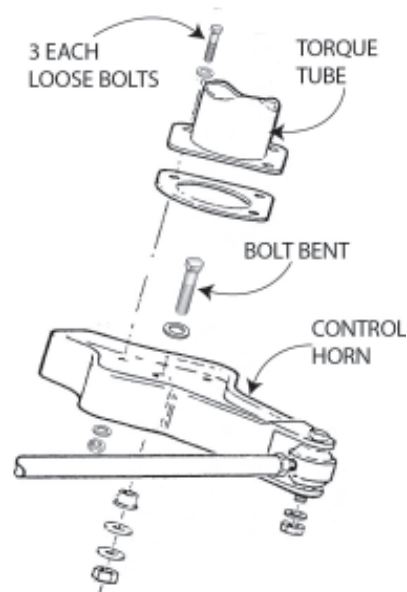
Beech; Model 1900D; Airliner; Rudder Control System Defects; ATA 2720

The rudder torque tube mount bolts were loose, and the control horn mount bolt (P/N AN175-17A) was bent. (Refer to the illustration.)

The submitter did not offer a cause for this problem. He recommended giving this area special consideration during inspections and maintenance.

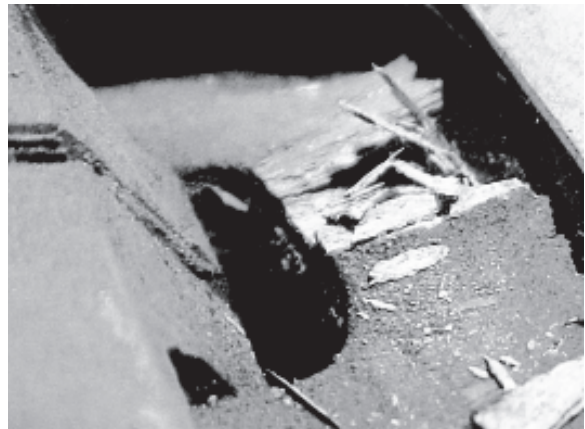
Cessna; Model 414A; Chancellor; Defective Wing Attachment Fitting; ATA 5740

The upper rear inboard wing spar (P/N 0822600-39) attachment bracket had been consumed by the effects of corrosion and was in danger of immediate failure! (Refer to the illustration.) Most of this aircraft's life had been spent parked outside. The submitter believes this was the major factor causing this defect. He speculated that corrosive contaminants entered through or around the panels and remained in contact with the attachment bracket.

The submitter made an important point concerning this finding. He observed that the state of this damage could not have progressed to the severity found since the last (or even more) scheduled inspections! It seemed evident that the aircraft had not been properly inspected or maintained in the past!

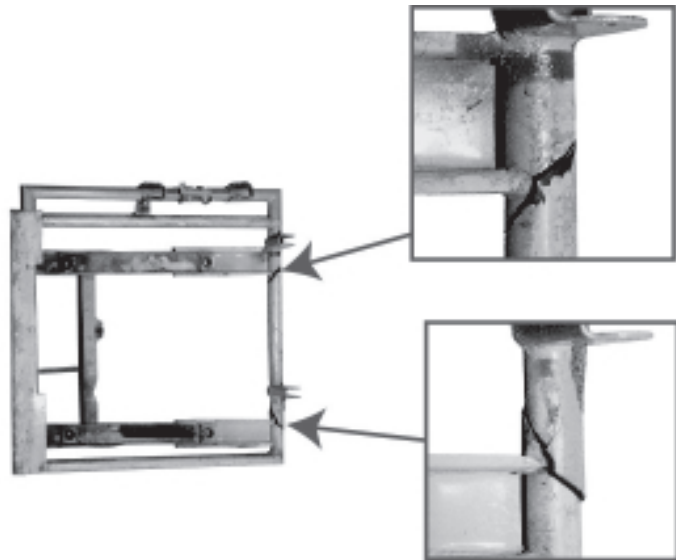
Cessna; Model 550; Citation; Cockpit Seat Structural Defect; ATA 2510

While inspecting the seats (P/N 5519015-13), the technician discovered severe structural defects on the pilot's position seat frame. The upper portion of the seat base (P/N 5519009-21) was cracked where the seat back attaches. (Refer to the illustration.) He speculated that stress on the seat back caused metal fatigue and led to the frame assembly failure.

The FAA Service Difficulty Program data base contains two additional reports of similar defects. Supplemental Type Certificate (STC) ST01042WI contains a repair process for this defect. This defect could lead to separation of the seat frame tube and seat back failure. This problem deserves close attention and immediate repair.

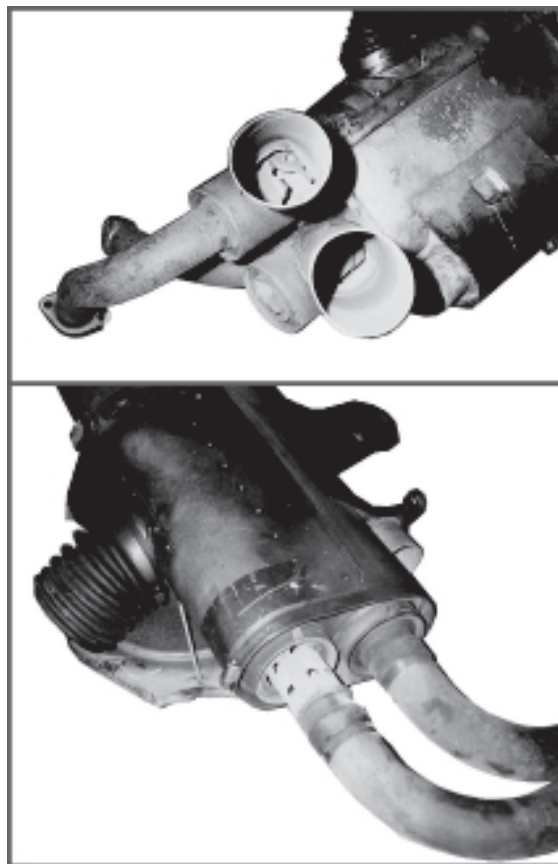
Piper; Model PA 28RT-201; Arrow; Defective Engine Muffler; ATA 7820

The (twin) muffler assembly (P/N 67517-00) appeared to be distorted and was cracked adjacent to one of the steel exhaust tubes. Investigating further, the technician found that the muffler internal flame tubes were loose, broken, and could be removed by hand. (Refer to the illustration.)

The submitter recommended that all concerned personnel pay close attention to the engine exhaust system during inspections and maintenance.
